ENGINEERING CASE LIBRARY

## DYNASHAM TRUCK COMPANY, LTD.\* (A)

## Truck Suspension Bolt and Bushing Failures

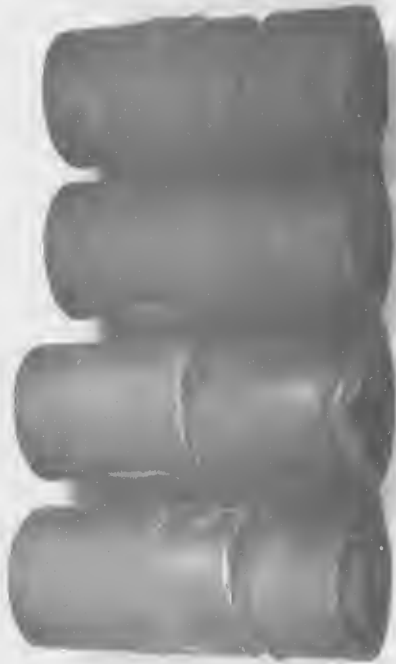
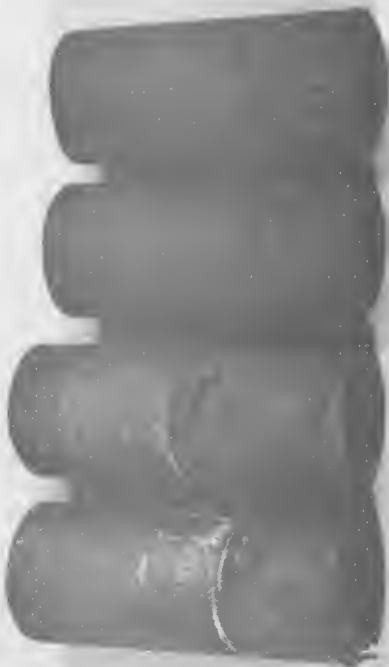
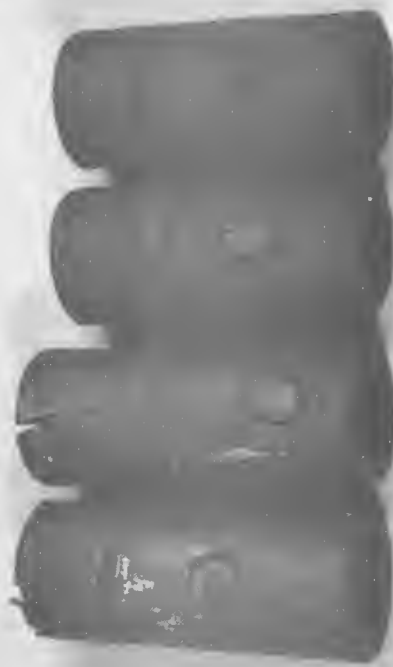
Exhibit 7: Failed Neoprene Bushings. 3 1/2 and 3 3/4 inch lengths.

When Lance was investigating the problem of inadequate bushing life in March 1958, about 200 air suspensions were in service on Dynasham trucks. The bushing then used as made from a 1-1/2 inch diameter cylinder of extruded neoprene in which a lengthwise hole had been drilled for the bolt. Each of the two bushings within an assembly was 3-1/2 inches long before compression; the Durometer hardness specification on the neoprene was 60 to 70. Bushings with a length of 3-3/4 inches were later used in an attempt to increase bushing life by compressing the rubber more. This helped only slightly, if at all. Typical premature failure of these bushings is shown in the photographs of Exhibit 7. Lance said, "Tearing occurred because the rubber in the adjustment block twists relative to that trapped in the hanger legs and also due to displacement of the adjustment block relative to the hanger. Both motions result in deformation of only a limited local volume of rubber. The small circular gouges on the surface of the bushings were caused by the compressed rubber working into the tapped through-holes in the adjustment block. These holes are for the shimmed capscrews at the front end of the block, which didn't extend to the ends of the holes."

When Lance began looking for causes of the bushing failures he also discovered that far from being under compression, the neoprene bushings were not even completely filling the cast holes in the two parts. He measured the bore of an adjustment block at several points with the results shown in the sketch of Exhibit 8. Obviously the bushing was not being compressed, but could work in the bore and be abraded. Lance also found that the corners of the bore, on both the adjustment block and the

hanger legs, which according to the drawings were to have a 1/8 inch radius, were actually being cast with a relatively sharp corner. This sharp corner tended to tear the rubber on the circumference of the bushing.

The first of the changes Lance O'Leary specified in an effort to increase bushing life was that longer capscrews be used in the tapped holes in the adjusting blocks. These would fill the holes completely so that the rubber could not extrude into them and tear.

Because Lance did not want to go to the expense of revising the adjustment block and spring hanger castings to remove the sharp corners on their bores, he decided to see if a machined chamfer on the corners of the bores would suffice to protect the bushings. He planned a series of tests, also trying different rubber compounds. Lance pointed out that natural rubber is much harder than neoprene and resists tearing better, thus it was an obvious choice for a better bushing. Intending to specify a larger natural rubber bushing that would be under compression when properly installed, he combined accelerated wear tests on various compounds recommended to him by a vendor with tests of the effect of chamfering the bore corners. The wear tests, primarily for tear resistance, were performed on an assembly consisting of a spring hanger, an adjustment block with bushings and bolt, and the lower spring leaf. Lance said, "I clamped the spring hanger upside down to a bench and pumped the spring leaf up and down by hand, using it as a lever to rotate the adjustment block through its maximum arc of travel. I did this until my arm gave out, which usually took about half an hour, counting strokes and cycling bushings made from rubber of each compound identically."

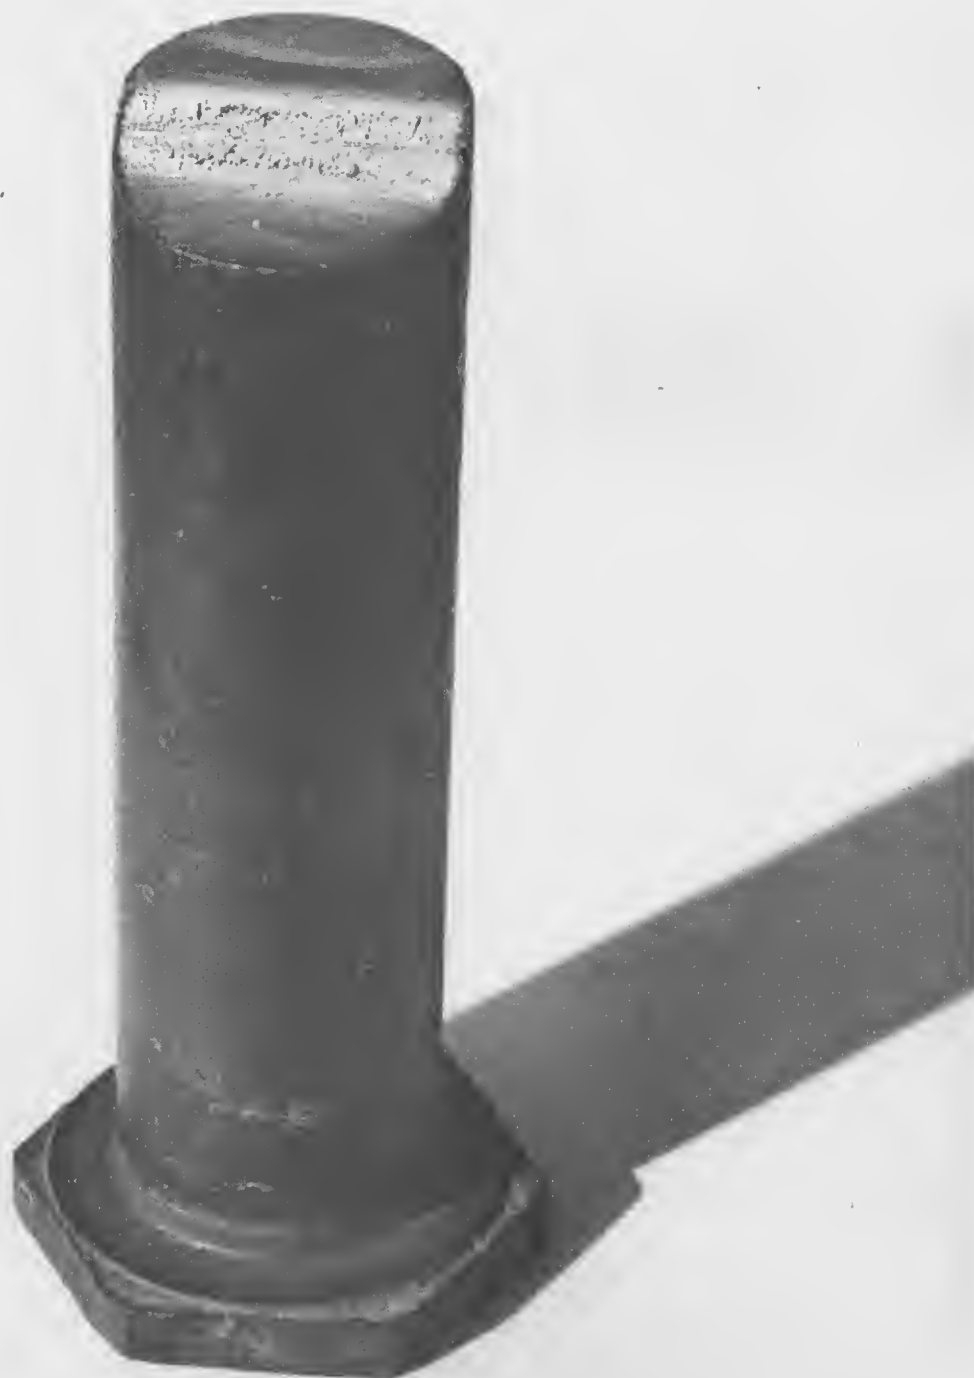
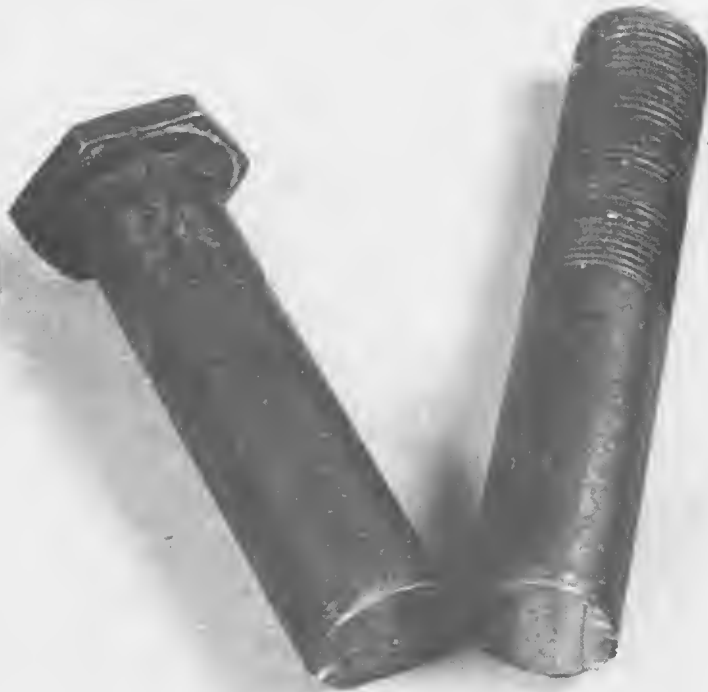
Exhibit 9: Fractured Grade 5 Pivot Bolt.

Several months later, Lance attacked the problem of pivot bolt failures. Known fractures of this bolt (some no doubt were never reported to Dynasham) totaled 32. The bolts were 8 inches long beneath the head; the diameter of the shank was 7/8 inch. Threads were cut on the last 2-1/4 inches after the blank had been cold forged and its head milled to a thickness of 3/16 inch. The thin head is necessary to provide clearance for tire chains. The material specification was SAE Grade 5. Photographs of the only two fractured bolts which were returned to Dynasham and made available to Lance are shown in Exhibits 9 and 10. As far as is known, all bolts broke approximately at their midpoints. This indicated to Lance that they were failing in bending. SAE Grade 5 bolts are medium carbon steel (.28% to .55% carbon), quenched in either oil or water and tempered at 800°F minimum. They must have a minimum yield strength of 81,000 psi and a minimum tensile strength of 115,000 psi. The hardness called for in the SAE specification is Rockwell C 22 to 32 at "a transverse section through the threaded segment at midradius." When Lance ground a flat about 1/4 inch wide on the shank of one of the broken bolts and checked its hardness, he found that the hardness varied from Rockwell C 11 to RC 27 at different locations, with an average value of 20 to 21. Some of the bolts had failed after only a few thousand miles, and Lance began to suspect that a batch of inferior quality bolts might have been installed in some of the air suspensions. He proceeded to have about 70 bolts checked for hardness; only about 10% were found to be as hard as the lower limit for Grade 5.

In its original application to trailers, the pivot bolt is subject only to braking loads and to a portion of the vertical loads. Since the top three leaves of each spring bear against the arch between the legs of the spring hanger, only one leaf of the spring transfers vertical loads to the frame through the bolt and bushing. In Dynasham's application to driving axles the bolt is subject to accelerating loads, and thus reversed loading in the fore and aft direction, as well.

In August 1958, the pivot bolt material specification was changed from SAE Grade 5 to SAE Grade 8. A drawing of the bolt appears in Exhibit 3. The Grade 8 bolts have the same carbon content as the Grade 5 bolts but they are a fine grained alloy steel, quenched in oil and tempered at 800°F minimum. Minimum yield strength is 124,000 psi; minimum tensile strength, 150,000 psi, and the hardness specification is Rockwell C 32 to 38.

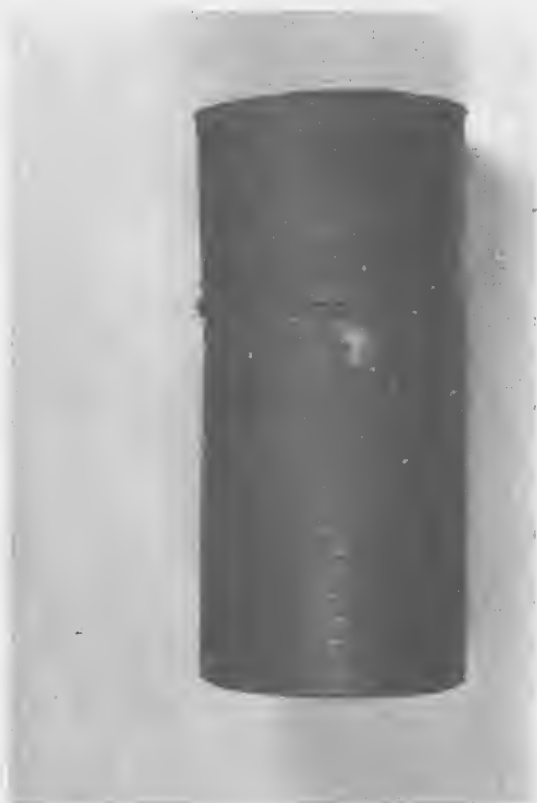
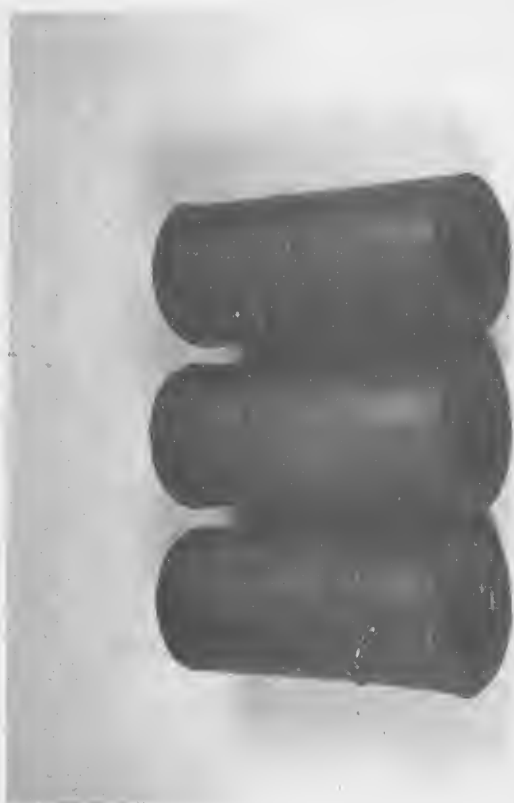
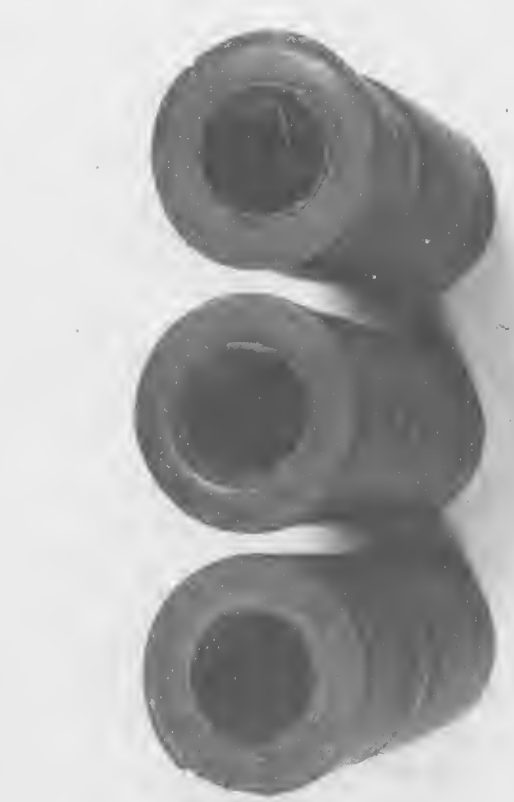
Exhibit 2: Worn Molded Natural Rubber Bushings. 3 1/2 inches Long.

By March 1959, although the extent of the improvement in bushing life had not been fully determined because of the usual difficulty in getting data from the field, Lance thought it obvious that further increases in life were needed, particularly as the applications of the air suspension were being extended to trucks of greater load capacity for use on interstate highways. Some of these trucks would weigh (in total, with trailers) as much as 127,000 lbs., an increase of as much as 50,000 lbs. Axle ratings would remain unchanged, but Lance said that loads on the pivot bolt and bushing would still be greater than before, particularly braking loads. Typical wear of the molded natural rubber bushings is shown in Exhibit 2. Mileages of these bushings are unknown, but well under 100,000 miles.

Of the failures of new bushings that Lance knew of in March 1959, many had been traced to improper installation -- either the pivot bolts had not been fully tightened and the rubber was not under sufficient compression or else shorter than specified capscrews had been used in the two tapped holes in the adjustment blocks.

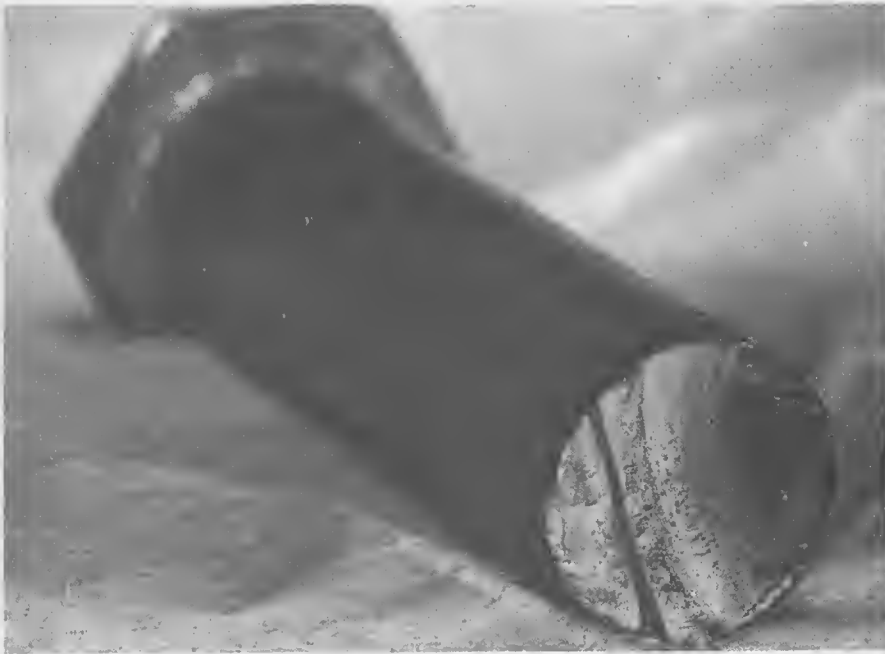
Exhibit 4: Fractured Grade 8 Pivot Bolt from Chip Truck.

Photographs of a broken bolt from one of the chip trucks appear in Exhibit 4. Lance said that chip trucks have an unusually high center of gravity which results in higher than normal suspension loads. He noted that the harder bolts appeared to show sharper and cleaner breaks than the Grade 5 bolts. Photographs of the broken bolt from the truck with end-dump trailer appear in Exhibit 5. Lance has had several batches of Grade 8 bolts checked for hardness -- one batch averaged about RC 31 to 32, another RC 41 to 42. While Lance did not know the mileages of the three broken Grade 8 bolts at failure, he felt that improvement in bolt life was needed, especially in view of the future demands to be placed on the air suspension.

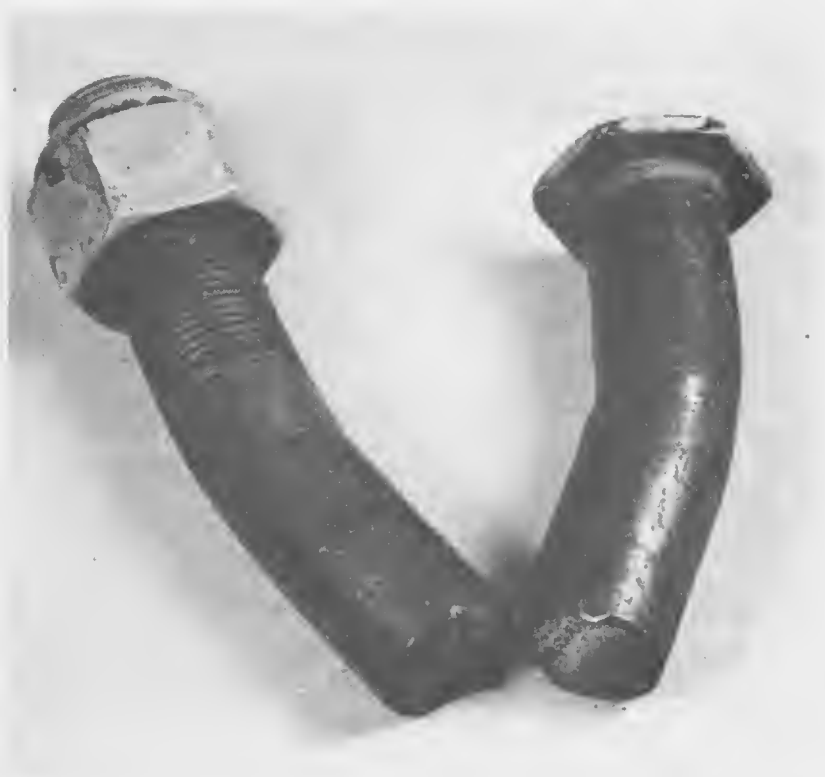
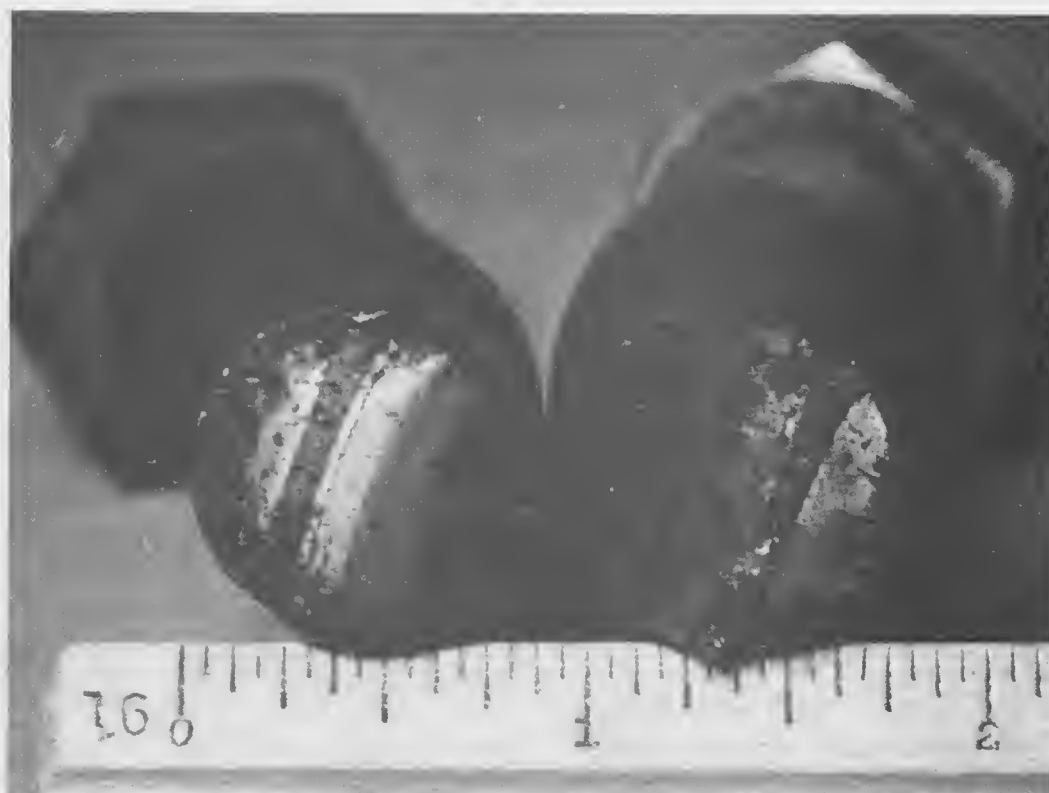
**Exhibit 5:** Fractured Grade 8 Pivot Bolt from End Dump Semi-Truck.  
Bolt Bent by Lance O'Leary to Check Ductility.

Three failures of Grade 8 bolts had been reported to Dynasham by March 1959. Lance said that all three bolts appeared to have been on the low side of the Grade 8 hardness tolerance band. He thought that the fatigue crack on one of the bolts had originated at a surface defect. All three failures occurred under conditions of particular severity -- two on trucks hauling wood chips and the other on a truck with an end dump semi-trailer used on construction work. Lance explained that these two applications were typical of the rough usage to which the air suspension would be subjected in the future.

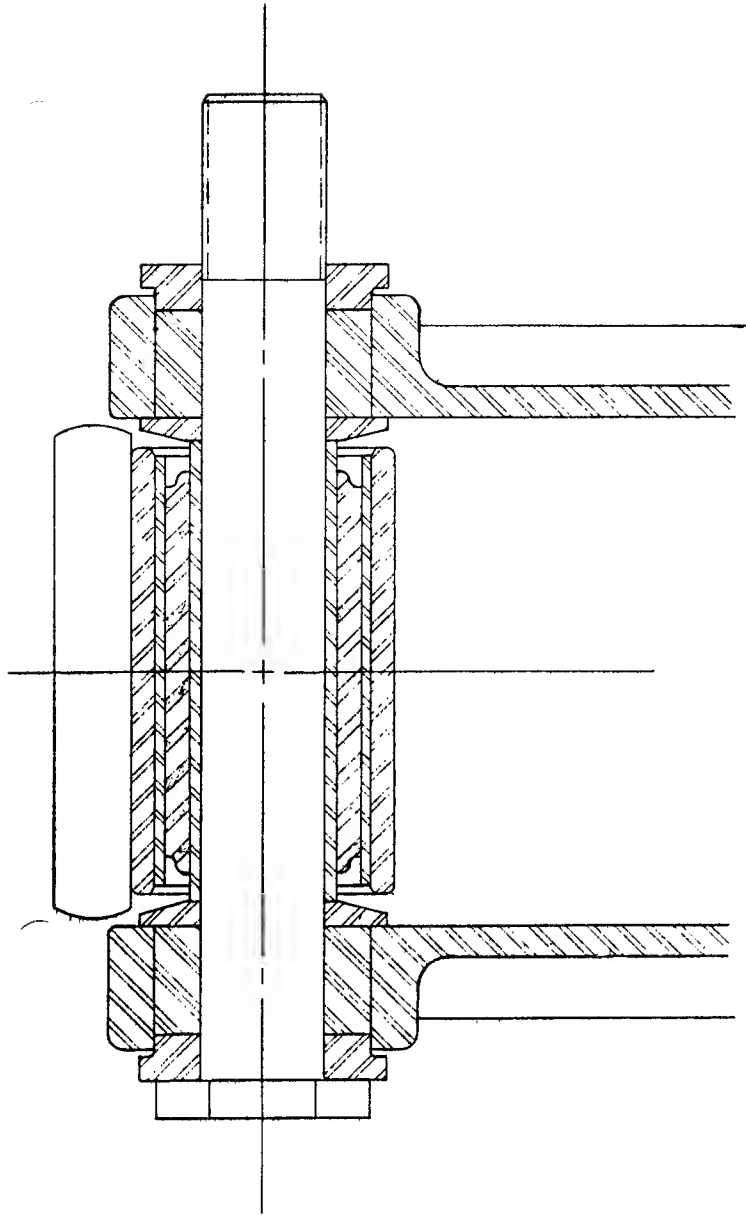
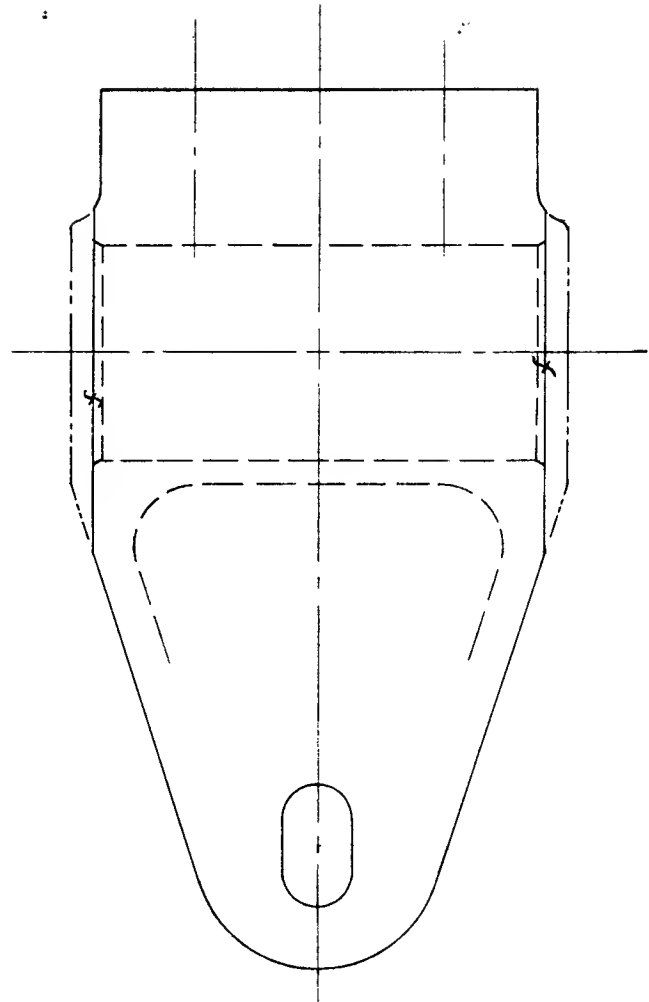
Exhibit 5: Clevite-Harris Bushing Assembly.

Since this design was obviously too expensive for general adoption, Lance drew up the similar but lower-cost alternative shown in Exhibit 5. A Clevite-Harris\*Silentbloc bushing which costs only \$3 would be used. With a one inch pivot bolt, the original adjustment block castings could be retained, but their bores would have to be machined to take the bushing. Delrin bushings are again shown in the hanger legs, but Lance used a stepped washer instead of a counterbore to cut costs. Lance also drew up a design using a Clevite bushing with a 1-1/8 inch bolt that would interchange completely with the Lord bushing design; for this installation new castings would be required. No assemblies with Clevite bushings were built.
